**SECOND SUPPLEMENTARY REPORT INTO THE DISAPPEARANCE OF JACK O’SULLIVAN  
BY**

Michael John Ferguson

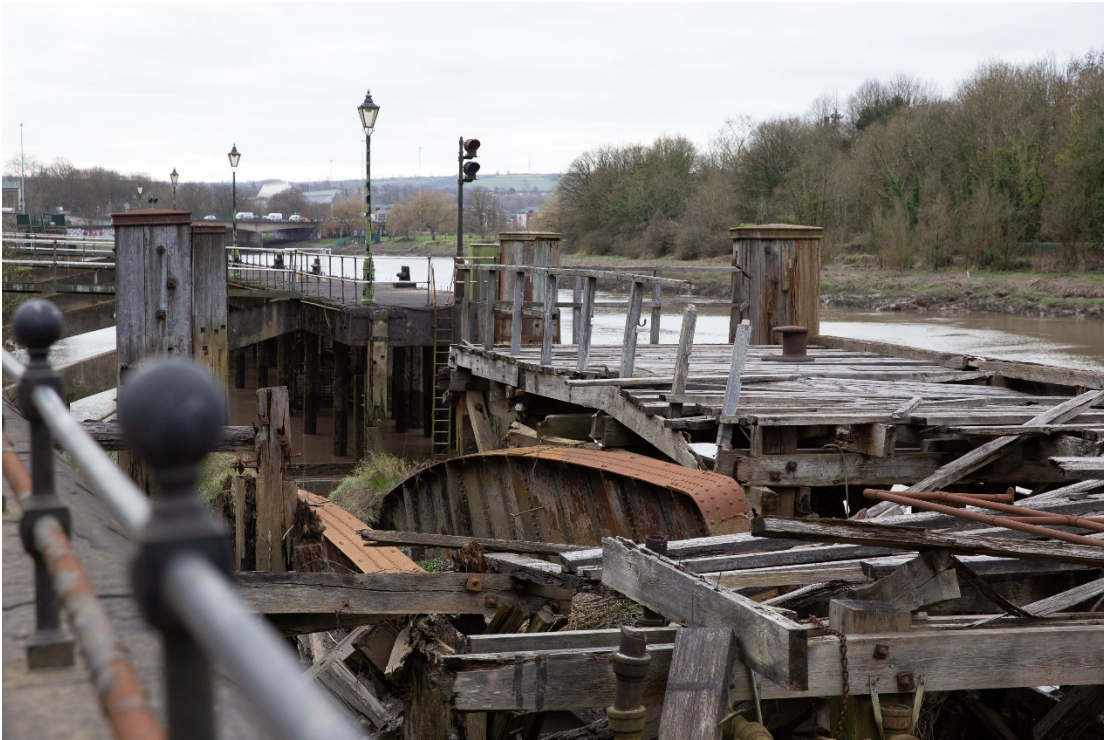
## Appendix 6

There is a small possibility that a body could have become snagged on the nearby Hotwell Pontoon (see appendix 6 and 7) and hidden from sight. Even though a search would be very dangerous due to the condition of the pontoon, a search could rule out this possibility.

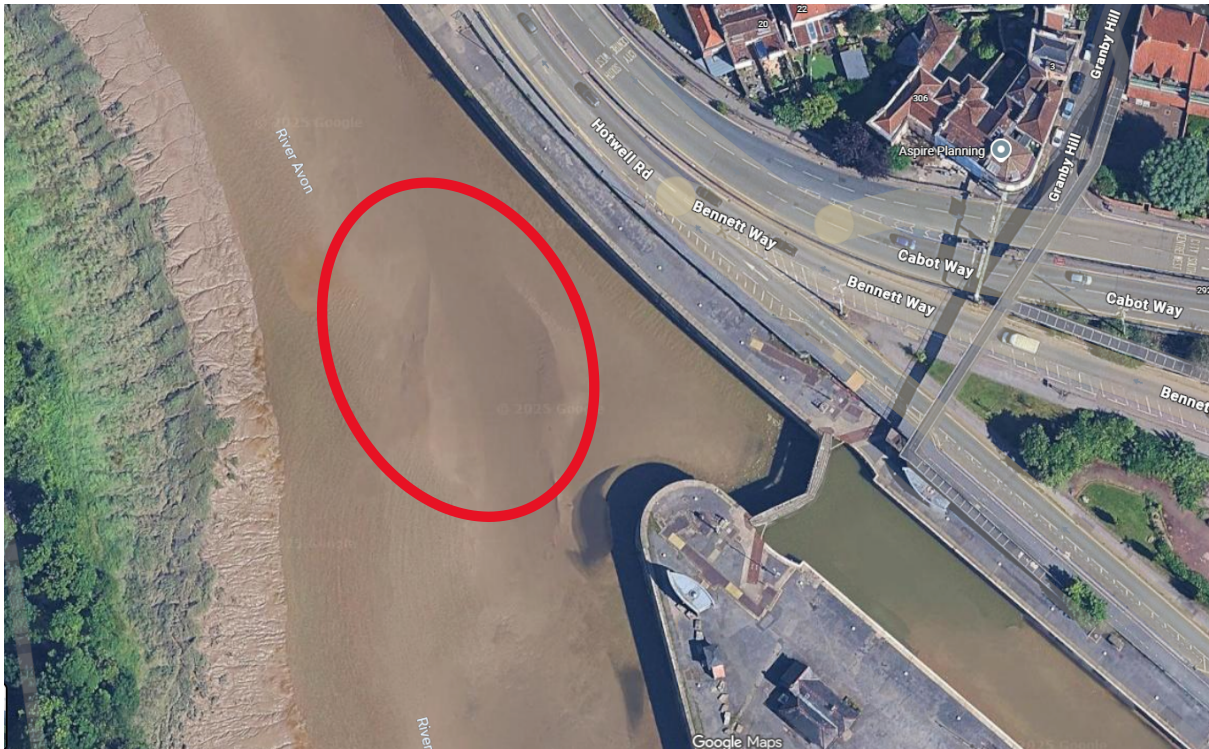
It is to be noted that the area indicated in Appendix 8 was plough-dredged in August 2025. Plough dredging is a method of underwater seabed levelling and material movement that uses a heavy, steel-framed "plough" or harrow towed by a tugboat. It works by scraping and collecting seabed material into a box as the plough is pulled ahead and then releasing the material when the tug reverses and lifts the plough out of the sediment. The ploughed material is dragged into the deepest part of the river and flushed away by the outgoing tide. This would have caused significant disturbance within the area indicated.
